# Manhole Inspection Summary

Manhole # S29OO1006MH

Insp Date: **7/2/07 12:23 PM**

**Location** Address: **4618 WILMSLOW RD**

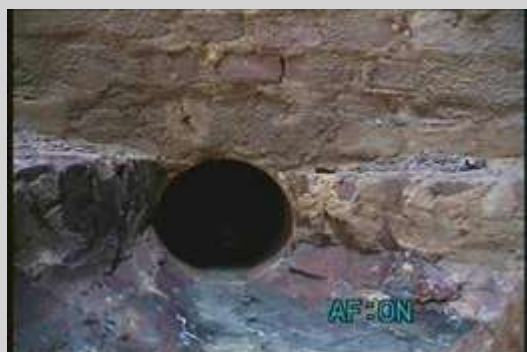
Pipe Out @ 12 O'Clock

### 8 in. Circular Gravity Sewer

Pipe Material: **Clay** ☐ Pipe Lined

Invert Depth: **7.50** (ft.) Flow Characteristics: **Slow**

Infiltration: **None** Pipe Seal Cond: **Unknown**

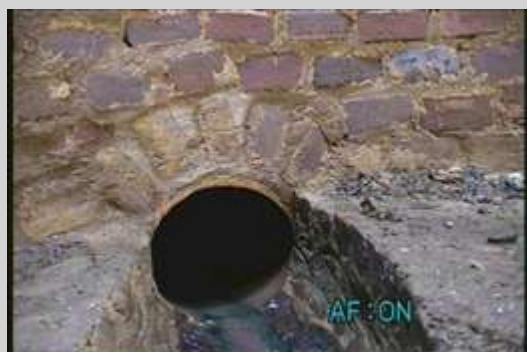
Pipe In @ 3 O'Clock

### 8 in. Circular Gravity Sewer

Pipe Material: **Clay** ☐ Pipe Lined

Infiltration: **None** Pipe Seal Cond: **Unknown**
